<b>QUALITY MANAGEMENT SYSTEM</b>	<b>Doc. No. QMSF-1025 TECHNICAL BULLETIN – ETM Power Supply</b>		
Not controlled in hard copy	Rev. 1.0	Date: 6/17/16	Page 1 of 5

Remanufactured XeMODeX ETM not functioning correctly after installation.

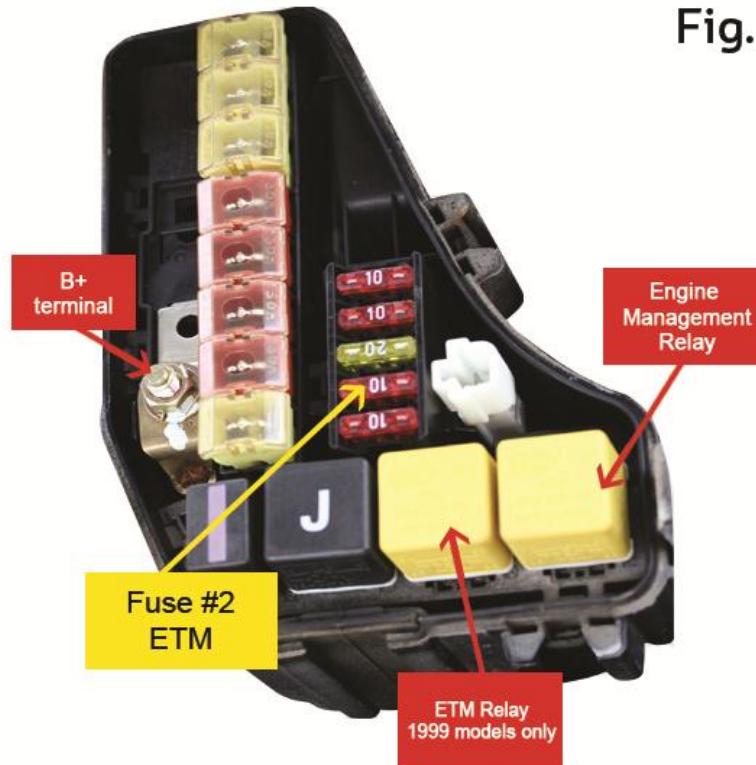
**Fig. 1**

Step 2: Locate fuse #2, pull it out and check if its blown. Replace if necessary with a 10 Amp fuse (see fig. 1). If the fuse is OK, proceed to the next test.

Step 1: Replace both relays (see fig.1) and test drive the car. If symptoms persist, proceed to Test 3.

Step 2: Remove the 13mm nut from the top of B+ terminal (see fig. 1).

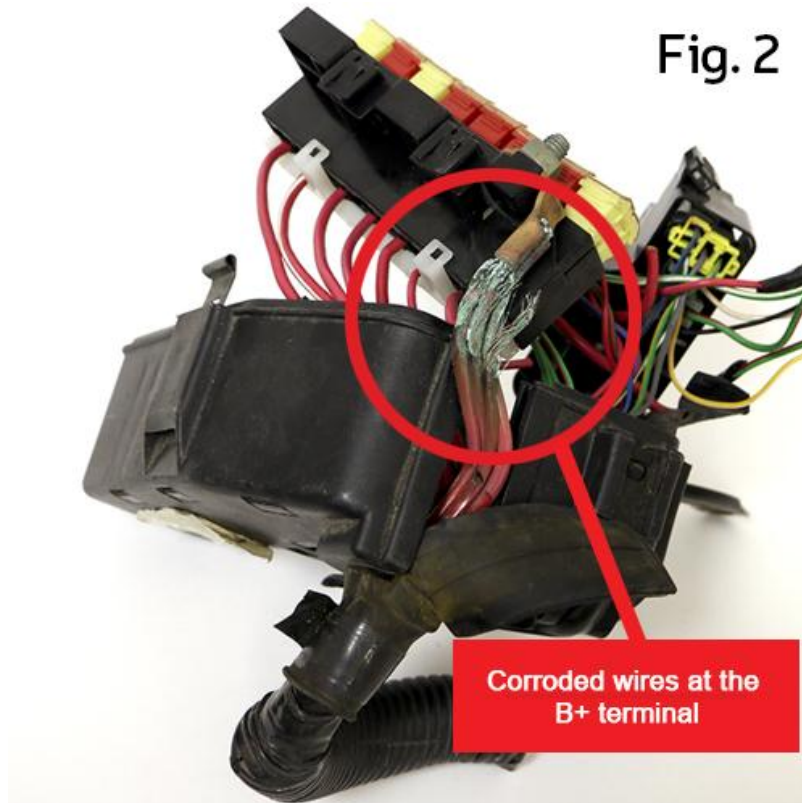
Step 3: Lift up the terminal and inspect the wiring condition. If the wiring looks anything like Fig. 2 below, repair the terminal (good repair instructions can be found on Matthew's Volvo Site / google B+ terminal repair). If the wiring looks OK, proceed to Test 4

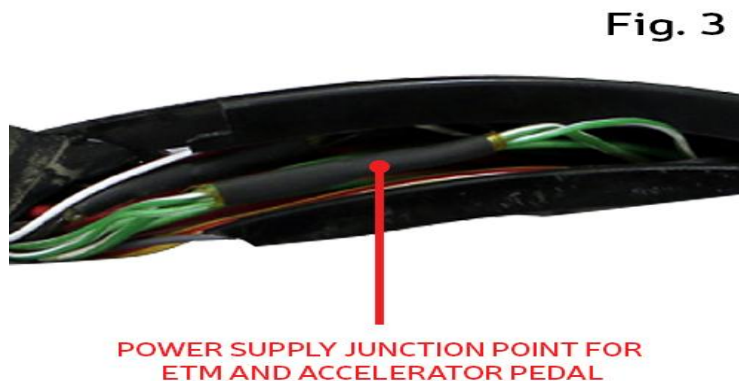
There is a hidden junction located in the engine harness about 8 inches from the fuse box (see fig. 3). This junction splits the power supplied by fuse #2 to the ETM and the accelerator pedal. It is very common for the wires to corrode there and cause significant current drop to the ETM.

It is not necessary to locate this junction point and repair it, we have a great success rate with simply by-passing the power supply directly from fuse #2 to the ETM.
