| QUALITY MANAGEMENT SYSTEM | Doc. No. QMSF-1025 TECHNICAL BULLETIN – ETM Blown Fuse | | |

Remanufactured XeMODeX ETM not functioning correctly after installation.

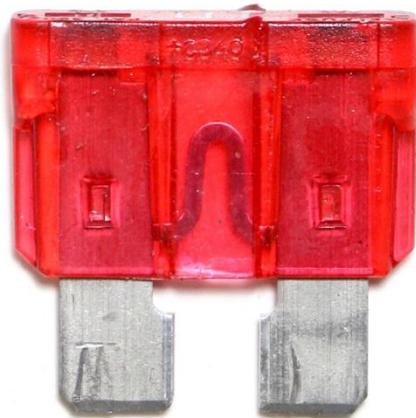
GOOD FUSE

Replace the 10 Amp ETM fuse located in the engine compartment on the left strut tower (refer to image below to reference what the fuse should look like).

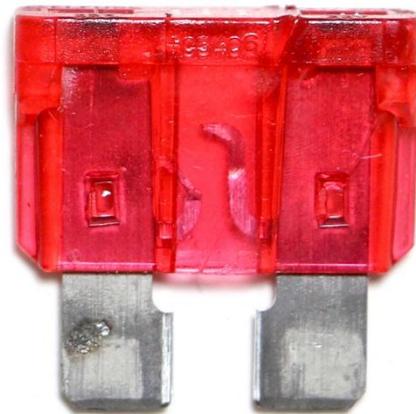
Blown ETM fuse

Short circuit in the original throttle blew the fuse.

BLOWN FUSE

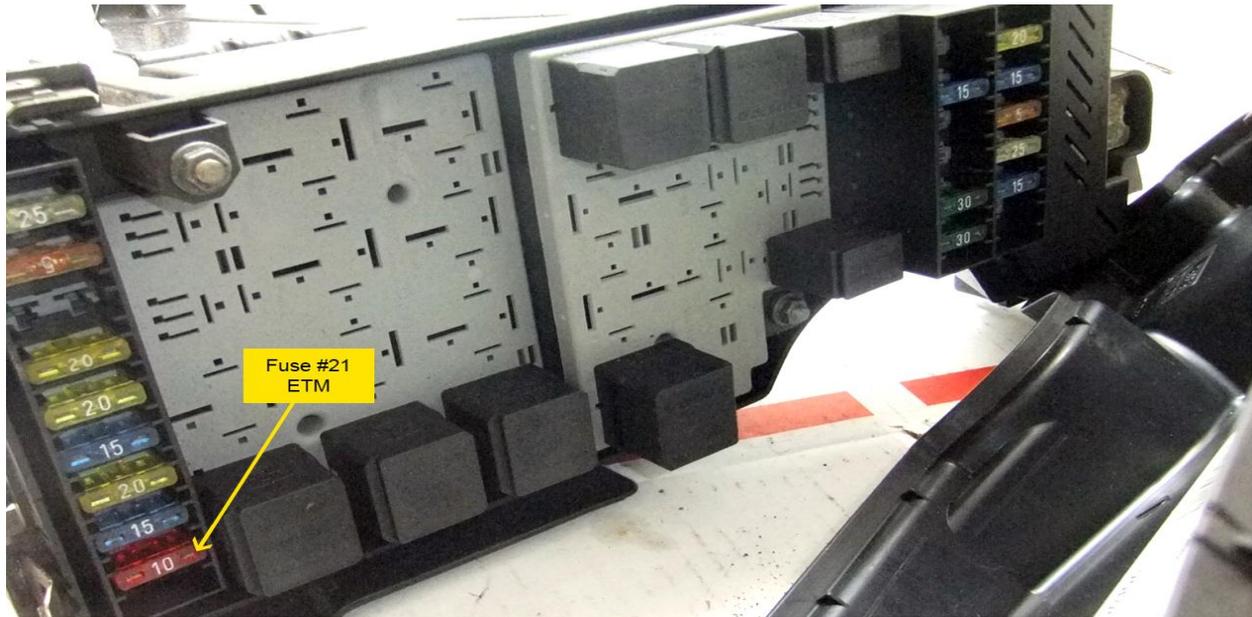
1999-2000 Volvo S80 ETM fuse location. Fuse #21

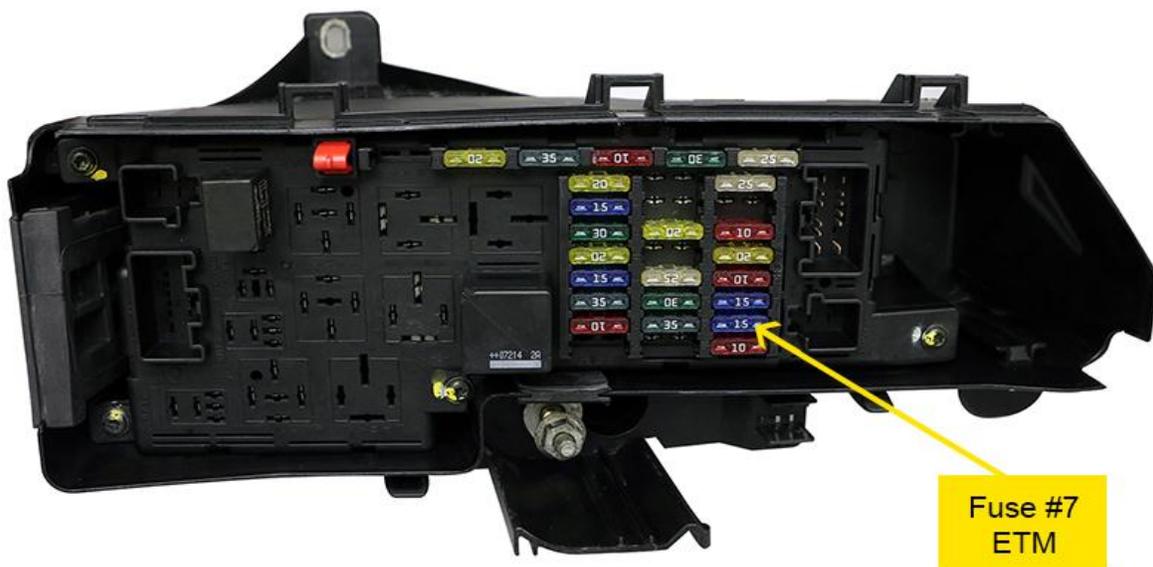
2001-2002 Volvo S60, V70, XC70, S80 fuse location. Fuse #7
